**APPENDIX C**

**SITE PHOTOGRAPHS AND THE CHAIN OF TITLE SEARCH**

**Vacant Undeveloped Land, 4700 Sundt Road NE, Rio Rancho, New Mexico – Photo Log  
Gamma Development**

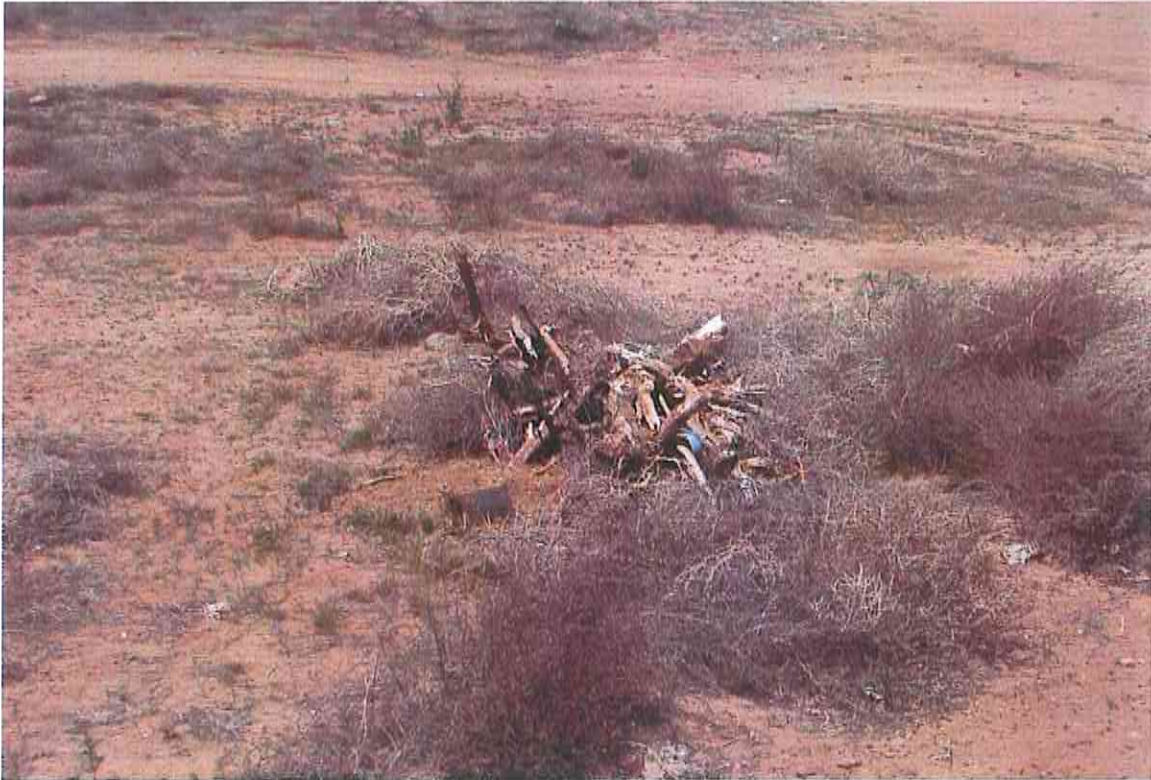
*No. 17 – Landscaping debris located in the center of the subject property.*

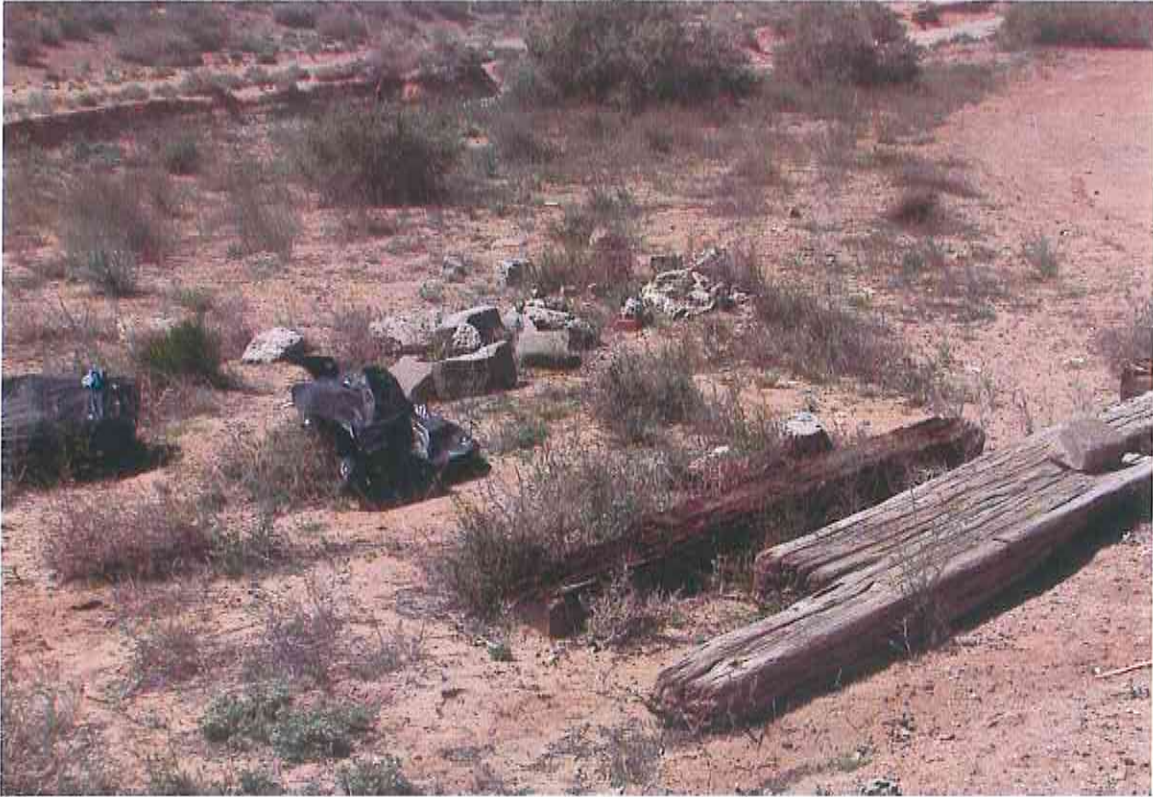
*No. 21 – Construction debris located on the southern portion of the subject property.*

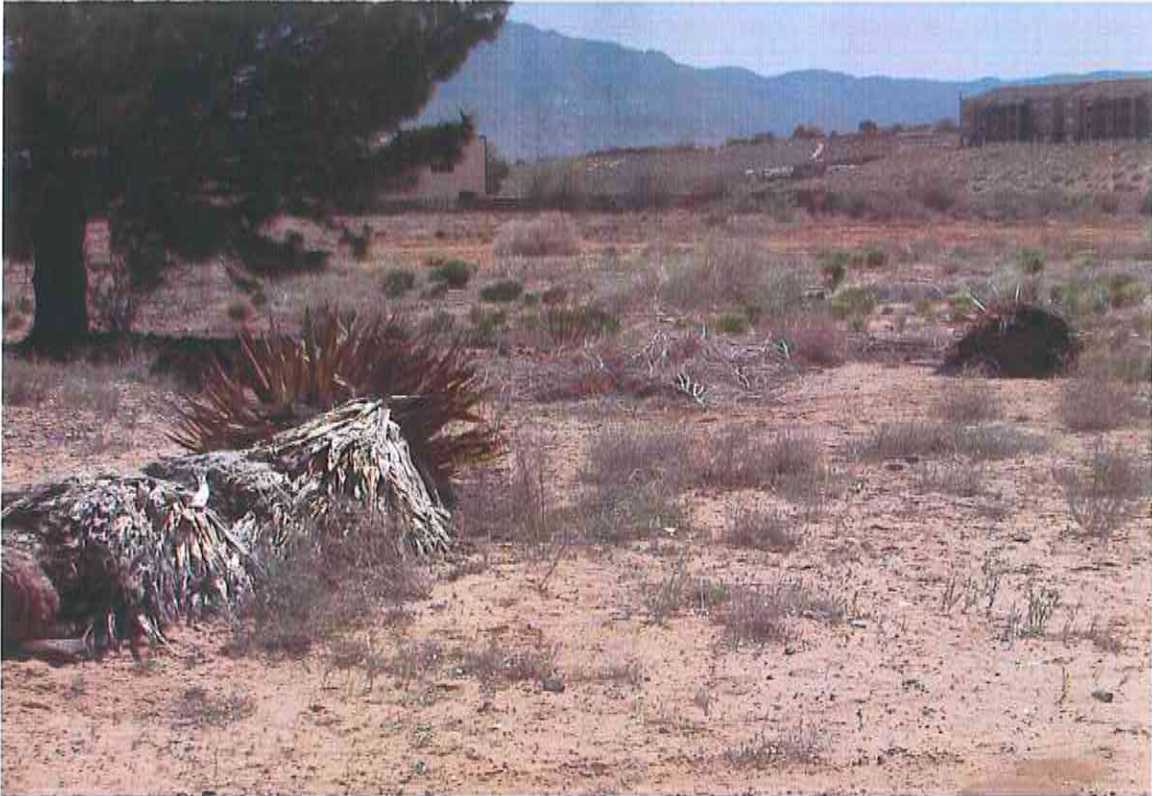
*No. 33 – Landscaping debris located on the western portion of the subject property.*

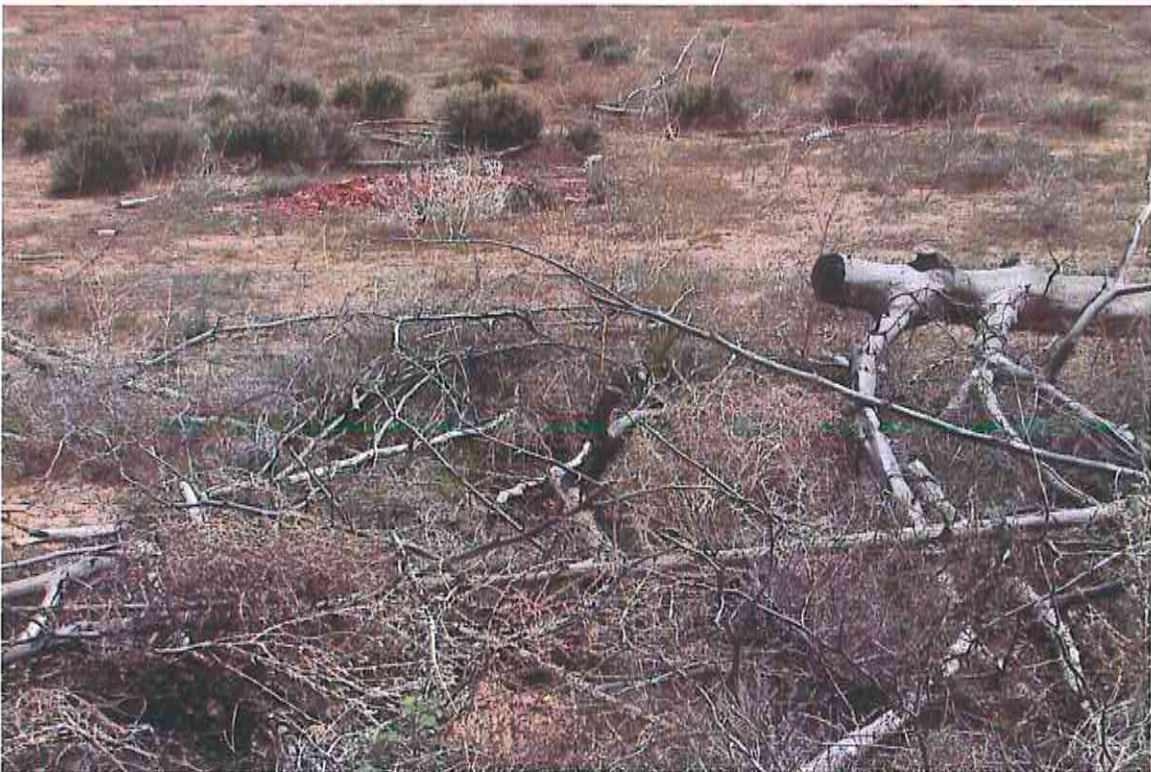
*No. 34 – Landscaping debris located on the western portion of the subject property.*

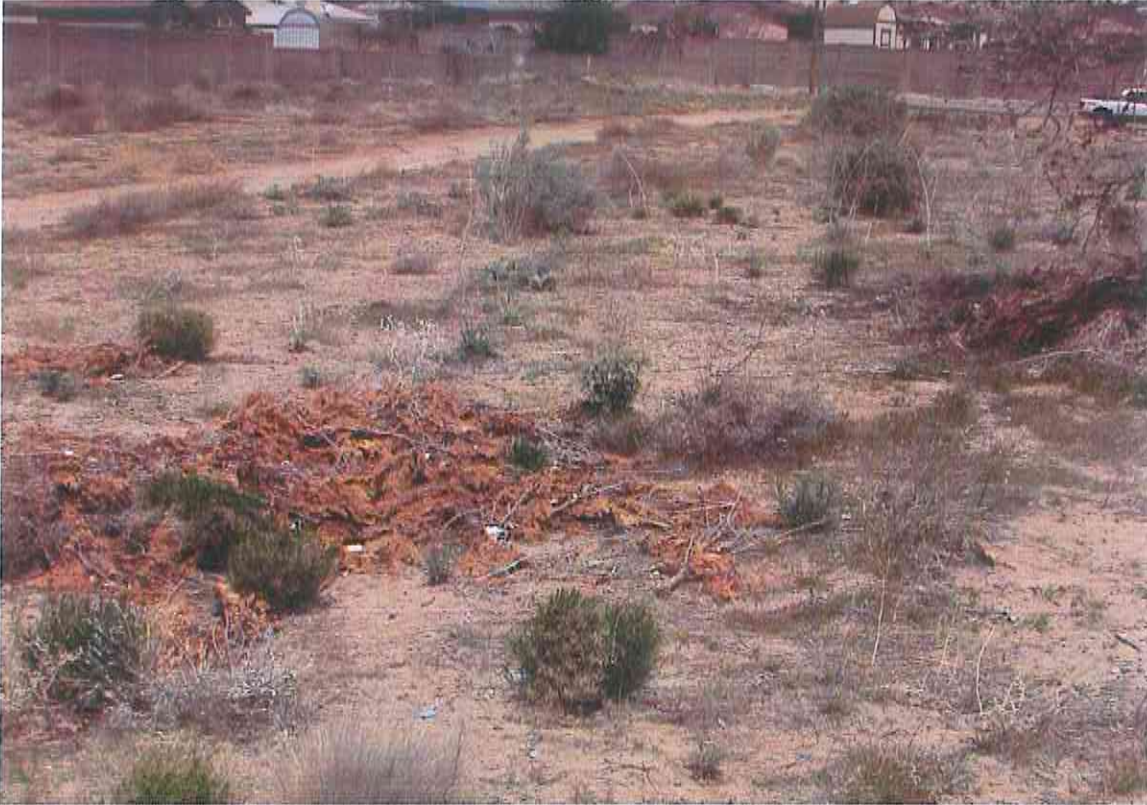
*No. 35 – Landscaping debris located on the western portion of the subject property.*

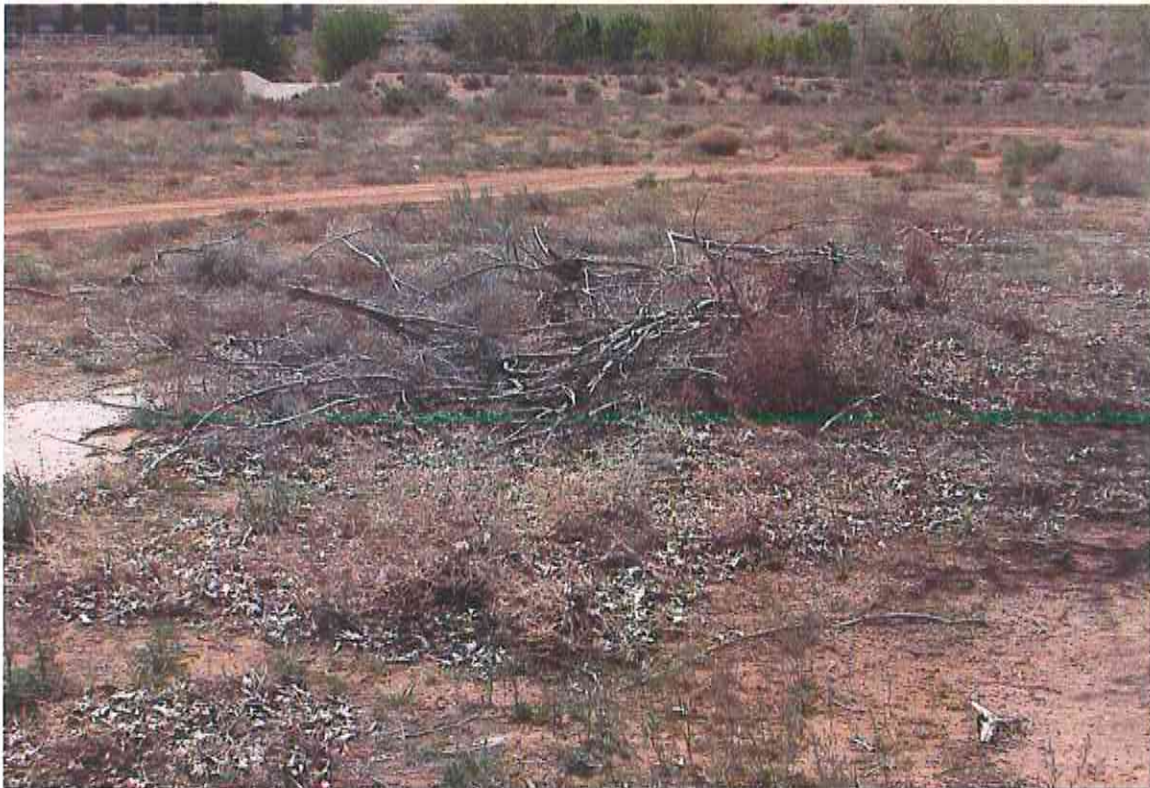
*No. 36 – Landscaping debris located on the western portion of the subject property.*

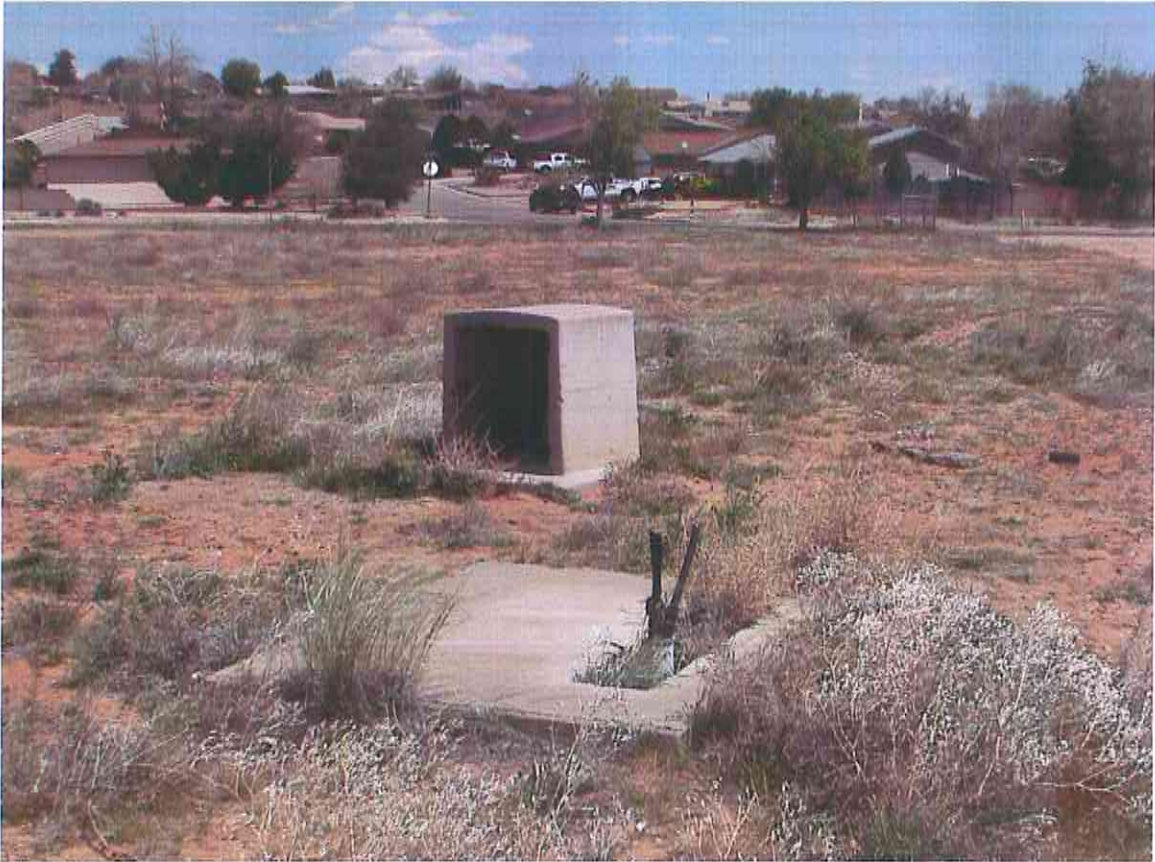
*No. 37 – Concrete encasement / utilities pad which has been abandoned.*

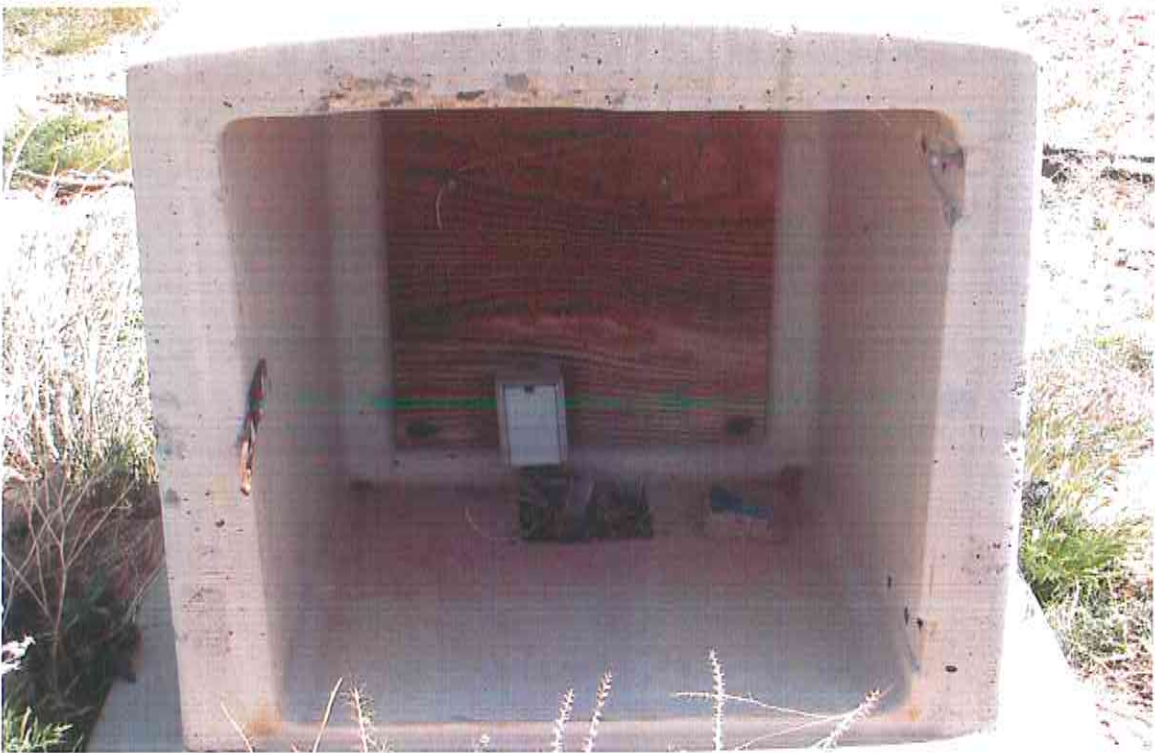
*No. 38 – Electrical outlet inside the concrete casing.*

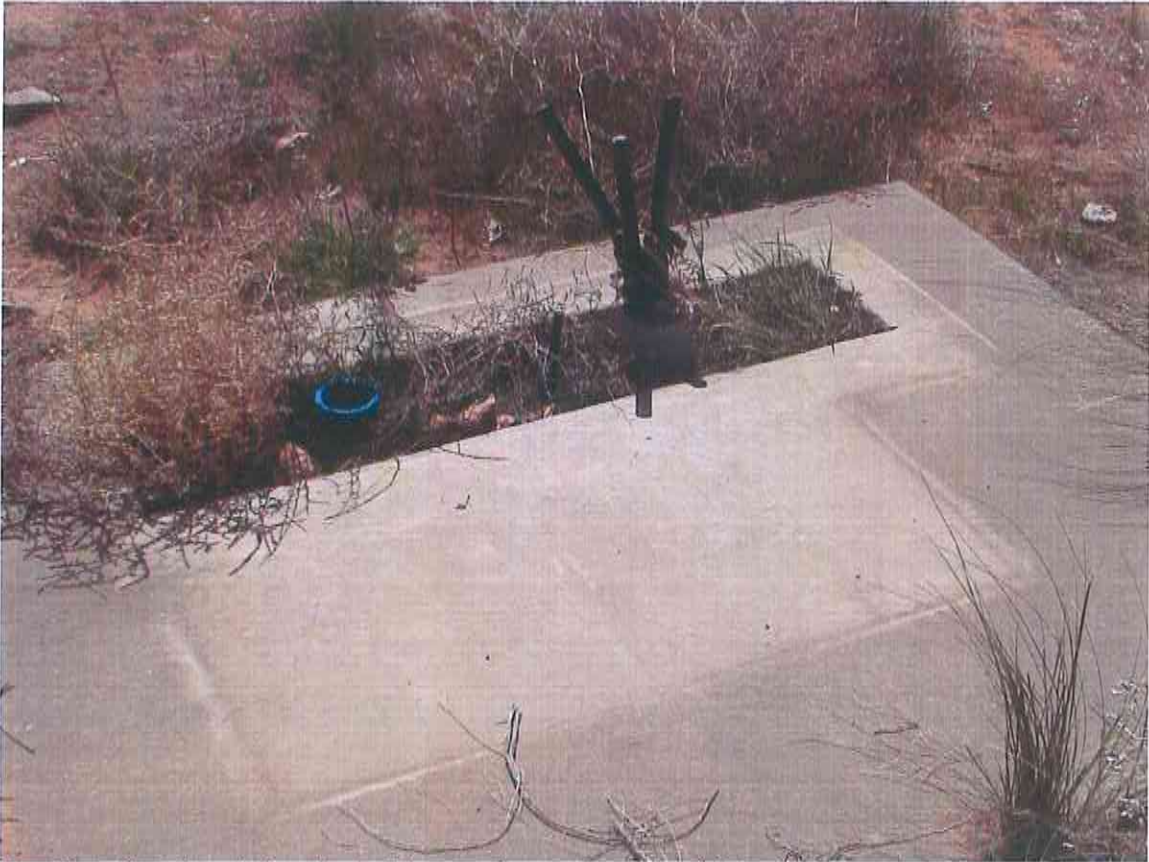
*No. 39 – Abandoned electrical wiring on the eastern side of the subject property.*
